Bridge Deck Cracking MDT 313162

Presentation Summary

- Introduction and Background on Bridge Deck Cracking
- Research Plan:
 - Item 4.1 – Literature Review
 - Item 4.4a – Field Inspections
 - Item 4.4b – Bridge Deck Instrumentation
 - Item 4.5a – Laboratory Evaluations
 - Item 4.5b – Finite Element Modeling
- WJE's Recommendations

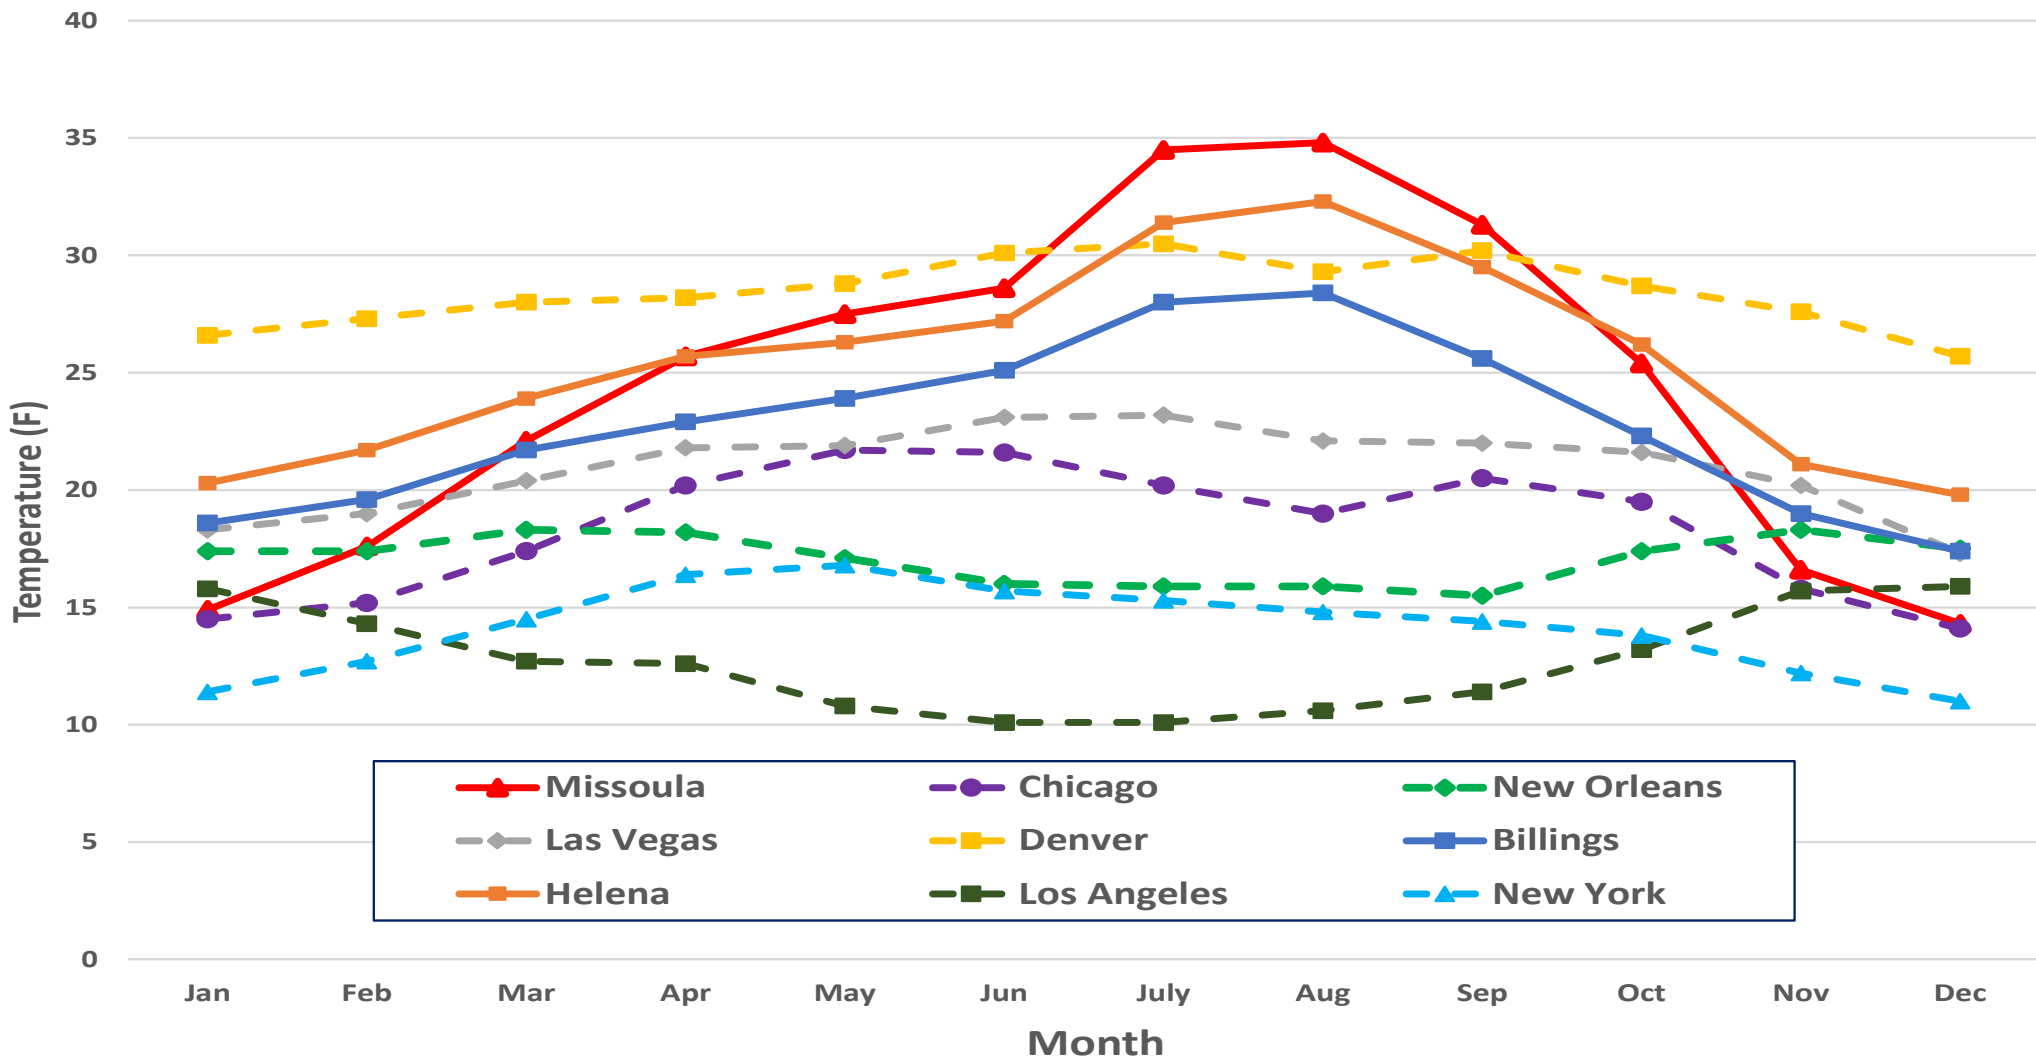
Average Daily Temperature Change by Month

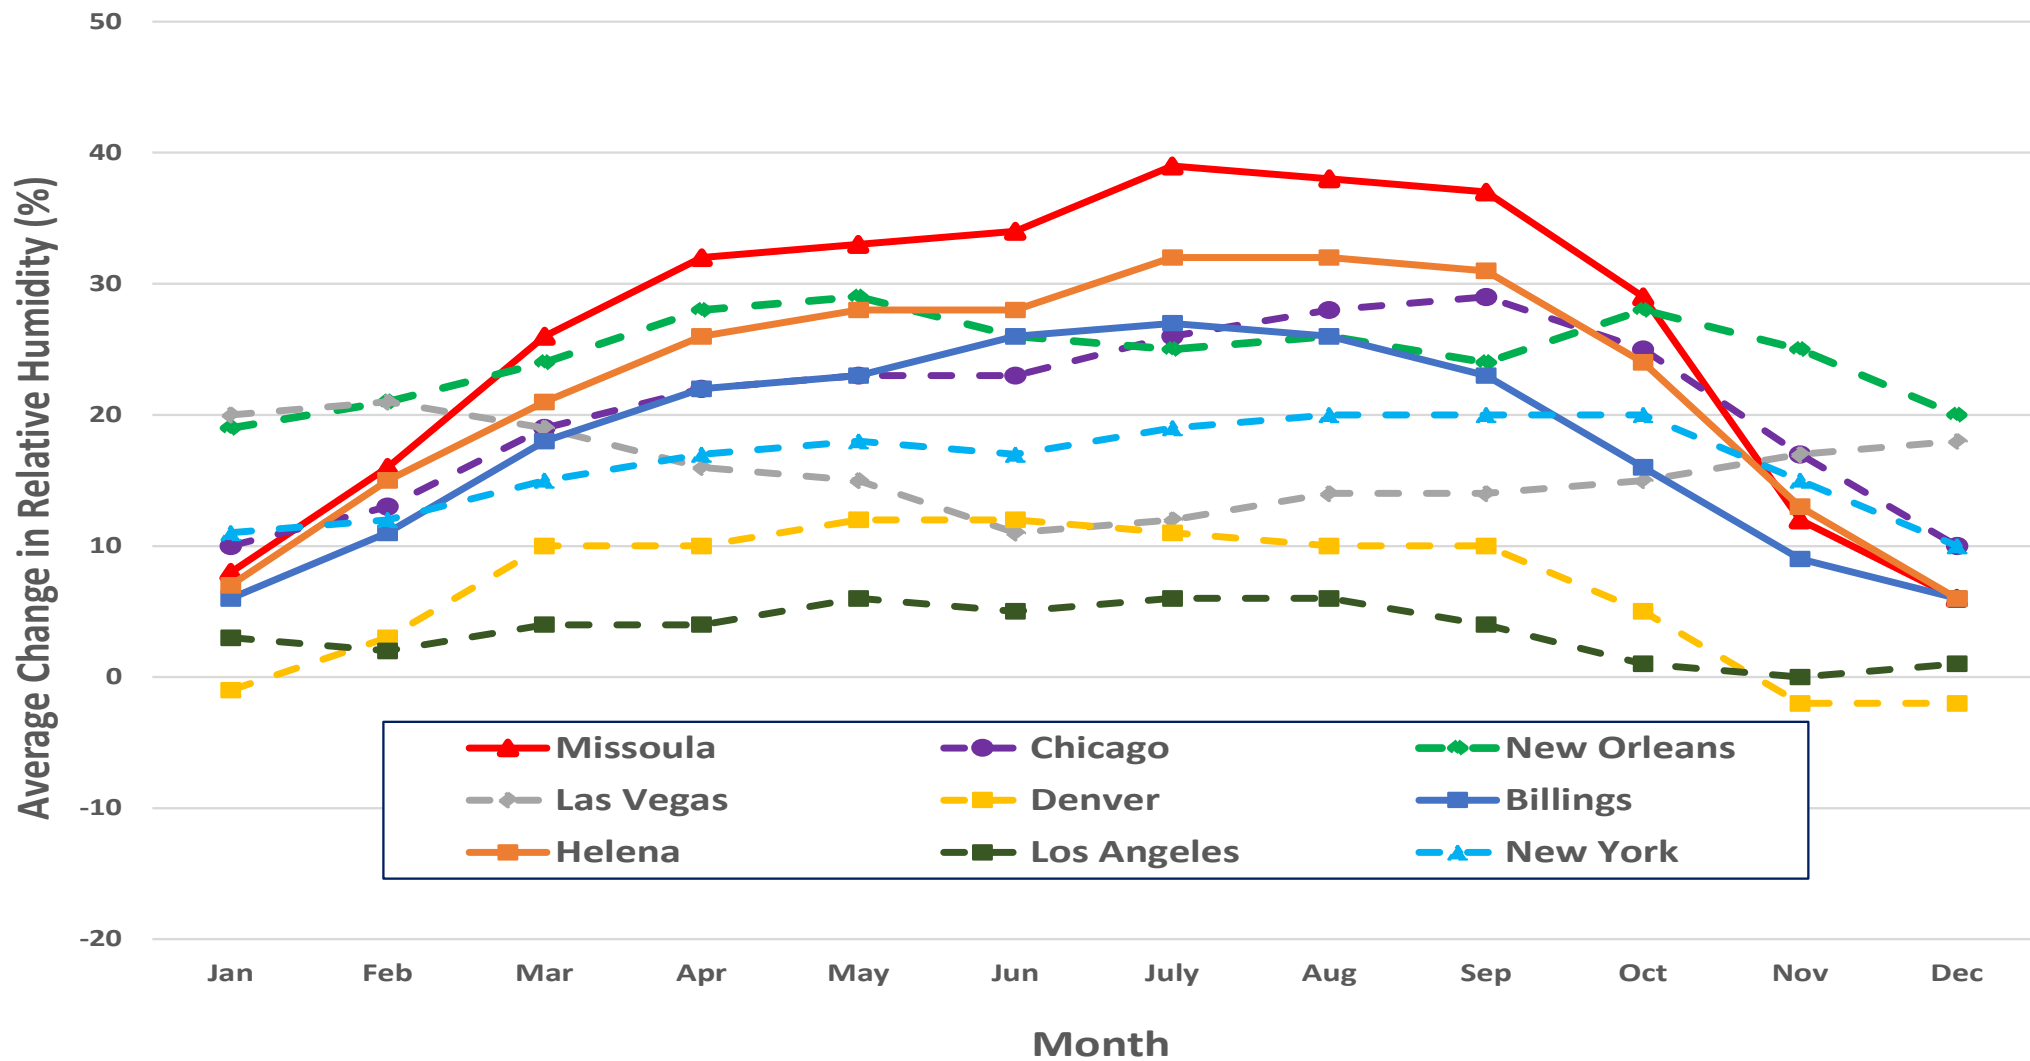
Average Daily Change in Relative Humidity by Month
